McGuffee Home Inspections

Dwelling Address: 10 I Love the Beach Lane
Somewhere in Florida

MHI General Home Inspection**GENERAL CONDITIONS**

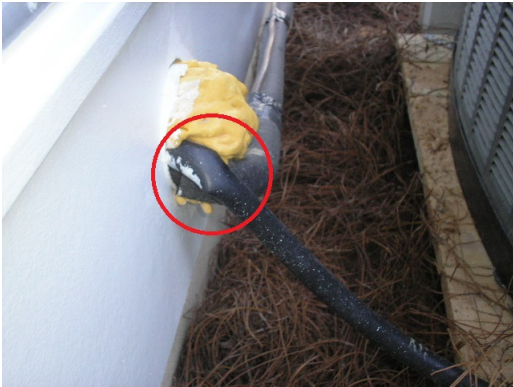
| Step # | Component | Comment |
|---|---|--|
| 2003. | General Conditions | Review. The condensate line is crimped where it comes through the exterior wall on the left side of the home and will not drain properly. Suggest repairing the condensate line so water can drain properly. |

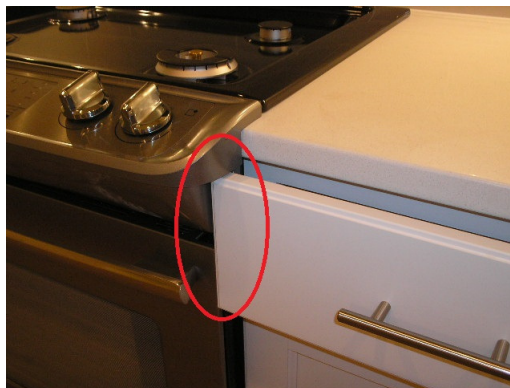
| Step # | Component | Comment |
|---|---|--|
| 2209. | Cabinets | Review. The drawer on the right side of the oven hits the oven when opening. Adjust the stove/oven in the counter opening so the drawer does not hit. |
